HYDRO-BLASTING PAINT REMOVAL STUDY

Michigan - August 2019

Daily Facility Services completed a hydro-blasting paint removal project for a Private Client in Michigan.

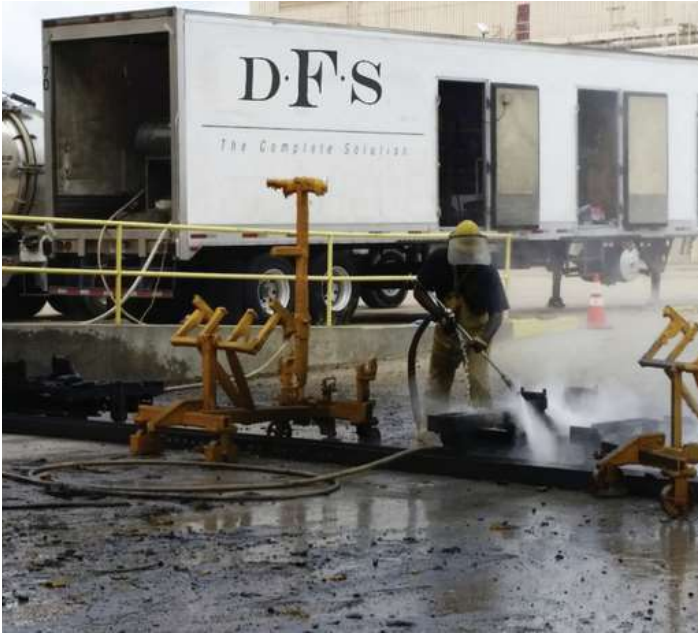
ABOVE: Blasting of chassis carts with 40k PSI hydro-blaster.

Daily Facility Services also cleaned front and rear chassis carts. These carts were also cleaned with 40k psi hydro-blasting. Previously, the process took four (4) hours to complete; DFS was able to fully clean the carts in an average of twelve (12) minutes.

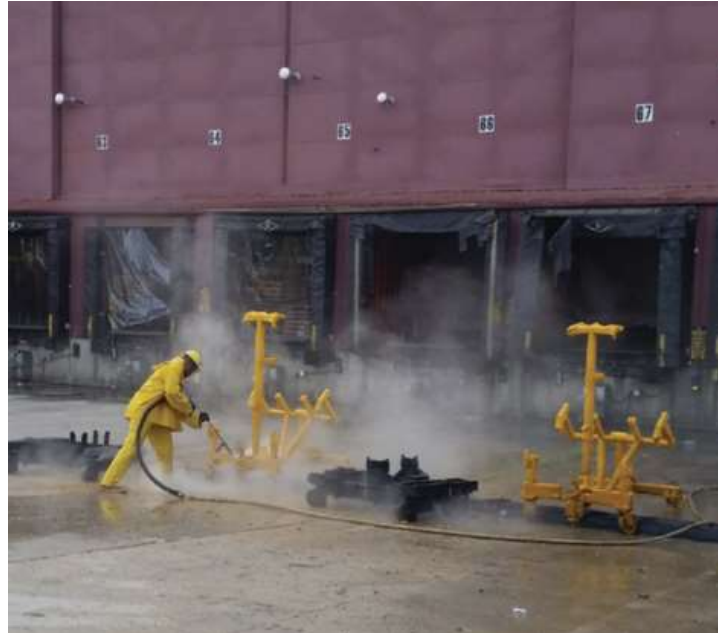
ABOVE: 40k PSI hydro-blasting of the paint carts

The Client manufacturers large vehicles and had been encountering long cleaning time issues with their paint carts. It would take as long as twelve (12) hours to clean a single cart. As a result, several of the carts had not been cleaned in four (4) years. Waste Solutions utilized 40k psi hydro-blasting to clean the paint carts. Comparatively, this process took as little as forty-five (45) minutes to clean each cart. Once the cart was cleaned, excess water was vacuumed and debris cleaned up. During off loading, the water was filtered to collect paint and debris, which was loaded into drums for disposal.

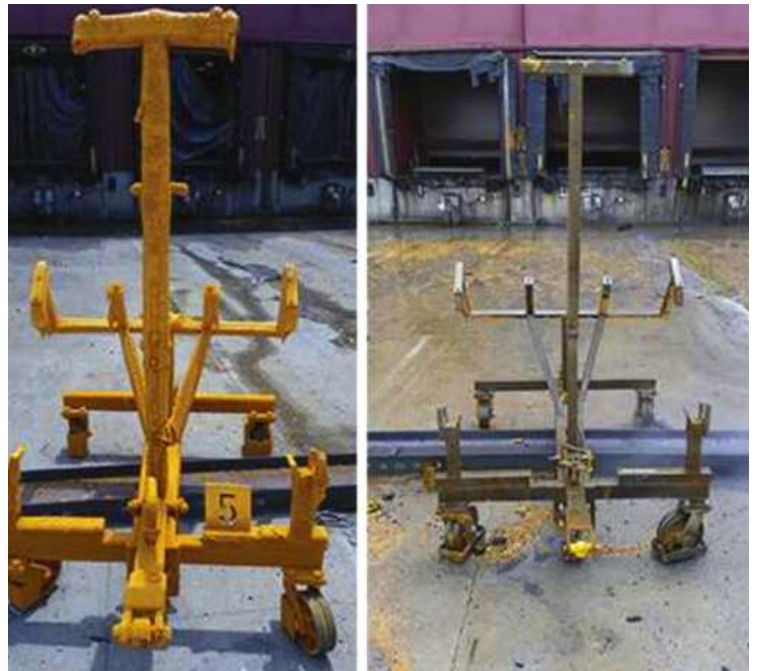
ABOVE (L) Before and (R) after photos of paint cart.
